WANAQUE GRADIENT CORROSION CONTROL REVIEW

City of Newark

Lead and Copper Rule Compliance Study Wanaque Gradient

June 28, 2019

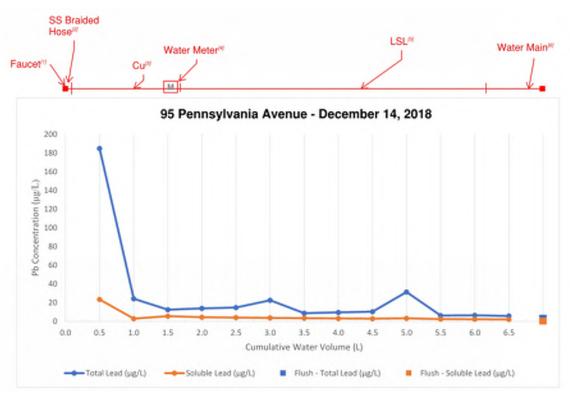
- The highest lead levels at this address were found in the interior plumbing components, including the faucet hosing. For the first sequential sampling, before the LSLR, soluble lead peaked at 23.4 μ g/L and total lead at 185 μ g/L in the first sample (on the faucet hosing and interior plumbing components). For the second sequential sampling (post-LSLR), soluble lead peaked at 19.8 μ g/L in the 12th sample and the total lead peaked at 108 μ g/L in the first sample. This appears to be all particulate lead and the homeowner should continue to flush without the aerator and replace the aerator.

- Significant particulate lead was found at this address in the first draw samples in both sequential sampling events. For the first sequential sampling, the aerator was removed on site prior to collecting samples but after flushing and stagnation. For the second sequential sampling, the aerator was removed prior to flushing and the stagnation period and remained off until sampling was completed.

- After flushing the water at the faucet for 10 minutes, the soluble lead was non-detect (ND), and the total lead was 2.96 μg/L for the first sequential sampling. After the service line was replaced, both the soluble lead and total lead concentrations were ND in the flushed sample. As noted above, a spike in lead levels was seen in the 6th liter (or 12th sample). This may be the corp stop connection to the water main that was disturbed during the replacement. The homeowner should continue to flush the line after periods of stagnation. Newark can retest the 5th and 6th liter to confirm this is decreasing over time.

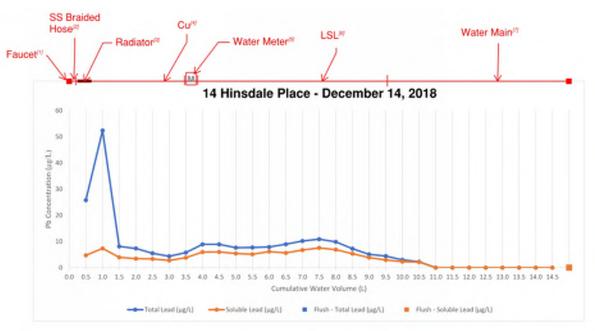
Figure 4-4 – 14 Hinsdale Place Lead Profile – December 14, 2018

- The highest lead levels at this address were found in the interior plumbing components, including the faucet hosing and piping connected to the faucet. For the first sequential sampling, before the LSLR, the soluble lead peaked at 7.35 μ g/L and total lead at 52.4 μ g/L in the second sample (in the interior plumbing components after the faucet). For the second sequential sampling, after the LSLR, soluble lead peaked at 14.4 μ g/L in the flushed sample and the total lead peaked at 17 μ g/L in the fourth sample.
- Elevated amounts of particulate lead were found at this address the interior plumbing. For
 the first sequential sampling, the aerator was removed prior to collecting samples, but after
 flushing and stagnation. For the second sequential sampling, the aerator was removed prior
 to flushing and the stagnation period and remained off until sampling was completed.

- The pH, temperature and chlorine residual were unable to be tested on site for the first sequential sampling. However, the temperature of the first 9 samples was fairly warm. During the site audit, a radiator was found to be located directly underneath a portion of the copper line in the basement. The radiator appears to be the source of the temperature increase and may have an impact on soluble and insoluble lead levels as warmer water increases lead levels in drinking water.

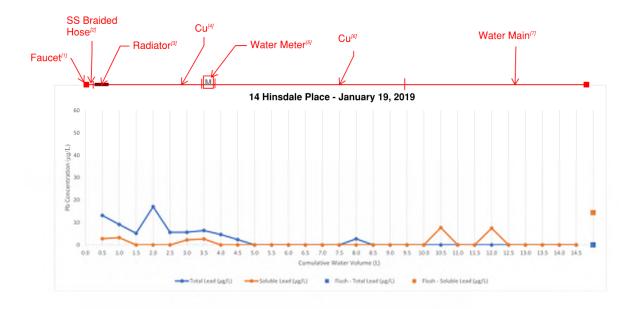
Figure 4-5 - 14 Hinsdale Place Lead Profile - January 19, 2019

- After flushing the water at the faucet for 10 minutes, both the soluble lead and total lead results were ND in the first sequential sampling. After the service line was replaced, the soluble lead concentration was $14.1 \, \mu g/L$ and the total lead was ND in the flushed sample. The samples where the soluble lead is greater than the total lead are not plausible and are considered erroneous.

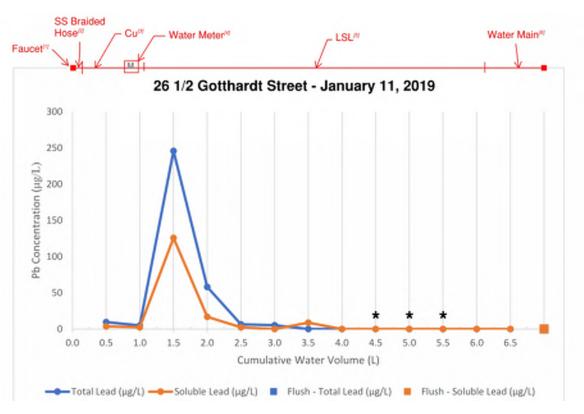
- The highest lead levels at this address were found in the interior plumbing components, including the faucet hosing and piping connected to the faucet. The aerator was connected to the faucet fixture and was unable to be removed for flushing and sampling. Soluble lead originally peaked at 261 μ g/L in the 10th sample (which was shown to be greater than total lead), but after re-testing the sample it was determined to be ND. The updated results determined that the soluble lead peaked at 126 μ g/L and total lead peaked at 246 μ g/L in the third sample, which represents the copper piping before the meter through a portion of the lead service line and includes the water meter and brass fittings. The samples where the soluble lead is greater than the total lead are not plausible and are considered to be erroneous.

- Elevated particulate lead was found at this address in the third sample.
- Silica concentrations were an average of 3.64 mg/L as SiO₂, which coincides with the Wanaque WQP ranges.

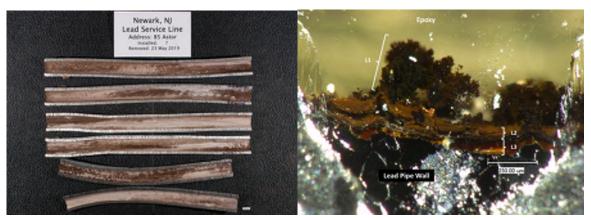
Figure 5-5 – Lead Scale Images for Pipe Extracted from 85 Astor Street

The scales found on the outermost layers were primarily plattnerite for 95 Pennsylvania Avenue and 85 Astor Street and calcium-hydroxypyromorphite with cerrusite for 14 Hinsdale Place and 285 Chestnut Street. Per the cross section analysis, 16 Hinsdale Place did not seem to exhibit a plattnerite texture. The middle portion of the scale seemed to be characterized by the presence of phosphorous.
