WANAQUE GRADIENT CORROSION CONTROL REVIEW

City of Newark

Lead and Copper Rule Compliance Study Wanaque Gradient

June 28, 2019

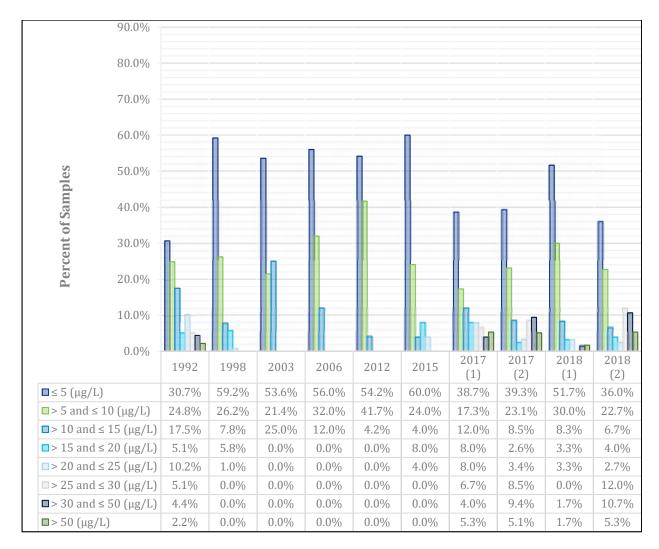
Figure 2-1 – Pequannock Service Area – Lead Sampling Data Percentage Frequency Distribution

Figure 2-1 provides an overview of the lead sampling compliance data from the ten (10) sampling events for the Pequannock service area for the different "bins" from less than 5 μ g/L to greater than 50 μ g/L. **Table 2-1** provides a summary of some statistical parameters based on the lead sampling compliance data, and **Table 2-2** provides an interpretation of the findings of the frequency distribution analysis for the Pequannock service area.

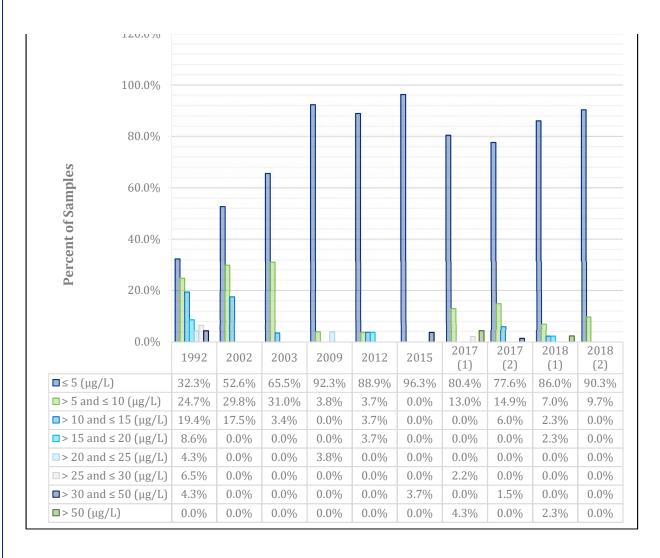
Figure 2-2 – Wanaque Service Area – Lead Sampling Data Percentage Frequency Distribution

Figure 2-2 provides an overview of the lead sampling compliance data from the ten (10) sampling events for the Wanaque service area for the different "bins" from less than 5 μ g/L to greater than 50 μ g/L. **Table 2-3** provides a summary of some statistical parameters based on the lead sampling compliance data, and **Table 2-4** provides an interpretation of the findings of the frequency distribution analysis for the Wanaque service area.

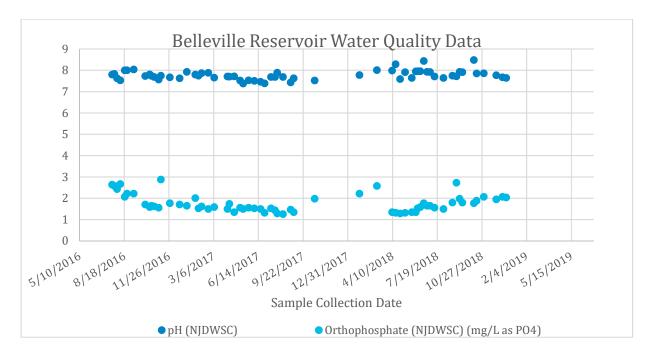
Figure 3-1 - Belleville Water Quality Data Trend

The data indicates that NJDWSC maintains a fairly consistent pH and orthophosphate residual at Newark's POE at approximately 7.8 and 1.76 mg/L (as PO₄), respectively, from the Wanaque system with occasional variations in pH or orthophosphate.

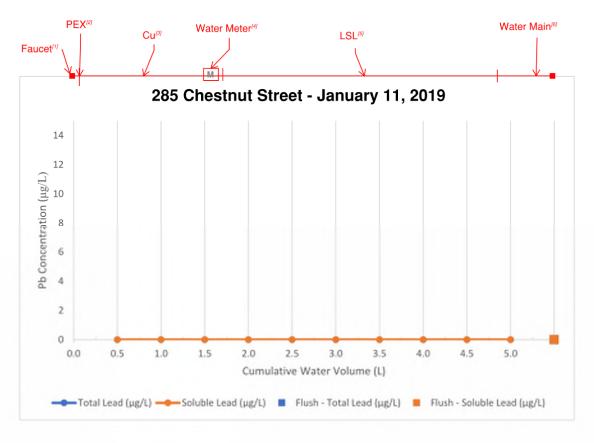
Figure 4-7 – 285 Chestnut Street Lead Profile – January 11, 2019

It was estimated that 285 Chestnut Street needed ten (10) 500 mL samples to encompass the entire interior plumbing and service line prior to reaching the main. This home had a lead service line and there was no lead solder found on the copper indoor plumbing before the meter. A portion of the lead service line was sent to the EPA for a cross section scale analysis following the sequential sampling event. The following are the observations for the lead profile results for 285 Chestnut Street, as shown in **Tables 4-7** and **4-8** and **Figure 4-7**.

- There was no lead detected in any of the samples at this address.
- The aerator was connected to the faucet fixture and was unable to be removed for flushing and sampling.
- Silica concentrations were an average of 3.70 mg/L as SiO₂, which coincides with the Wanaque WQP ranges.
- Orthophosphate measurements were an average of 2.08 mg/L as PO₄, which coincides with the Wanaque WQP ranges.
- Based on the water quality data collected at the tap, this location does not appear to have been influenced by the Pequannock Gradient water at the time of the sampling event.
- The total copper results were ND for all samples.

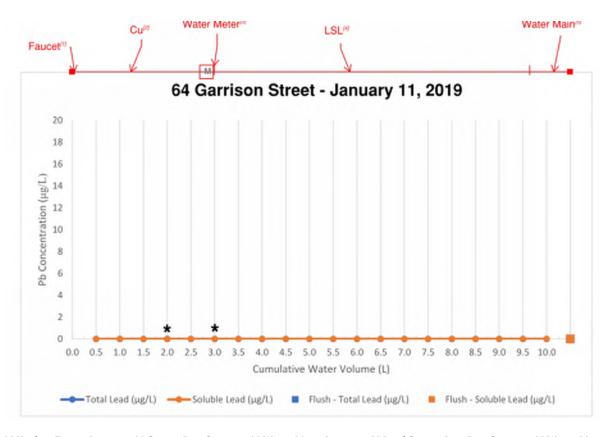
Figure 4-8 – 64 Garrison Street Lead Profile – January 11, 2019

It was estimated that 64 Garrison Street needed twenty (20) 500 mL samples to encompass the entire interior plumbing and service line prior to reaching the main. This home had a lead service line and lead solder with copper indoor plumbing before the meter. The following are the observations for the lead profile results for 64 Garrison Street, as shown in **Tables 4-9** and **4-10** and **Figure 4-8**. It should be noted that some samples were re-tested by the laboratory for quality assurance. Both sample results, when applicable, are provided in **Table 4-10**.

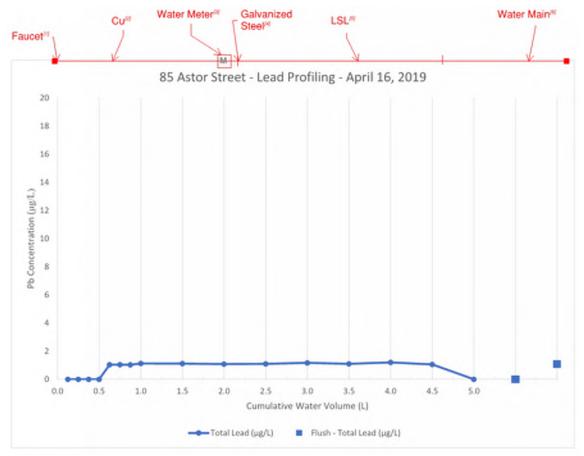
Figure 4-11 – 85 Astor Street Lead Profile – April 16, 2019

The address 85 Astor Street is located in the South Ward. The mapping in **Figure 4-1** shows the address in the East Ward based on the previous ward boundaries. It was estimated that 85 Astor Street needed (9) 500 mL samples to encompass the entire interior plumbing and service line prior to reaching the main, in addition to collecting eight (8) 125 mL bottles to represent the first liter. This home had a lead service line and lead solder with copper and a segment of galvanized steel indoor plumbing. A portion of the lead service line was sent to the EPA for a scale analysis following the sequential sampling event. The following are the observations for the lead profile and water quality results for 85 Astor Street, as shown in **Tables 4-15**, **4-16** and **4-17**, and **Figure 4-11**. It should be noted that laboratory analyses not performed in the field was performed by the EPA Region 2 laboratory for this site.

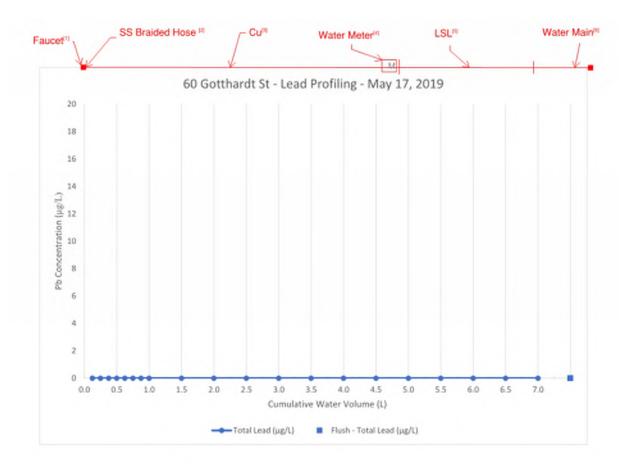
Figure 4-13 – 60 Gotthardt Street Lead Profile – May 17, 2019

It was estimated that 60 Gotthardt Street needed twelve (12) 500 mL samples to encompass the entire interior plumbing and service line prior to reaching the main, in addition to collecting eight (8) 125 mL bottles to represent the first liter. This home had a lead service line and lead solder with copper and a segment of galvanized steel indoor plumbing. The following are the observations for the lead profile and water quality results for 60 Gotthardt Street, as shown in **Tables 4-21**, **4-22** and **4-21**, and **Figure 4-13**. It should be noted that laboratory analyses not performed in the field were performed by the EPA Region 2 laboratory for this site.

- There was no lead detected in any of the samples at this address.
- The aerator was removed before collecting samples.
- Silica concentrations were an average of 4.41 mg/L as SiO₂, which coincides with the Wanaque WQP ranges.
- Orthophosphate measurements were an average of 1.60 mg/L as PO₄, which coincides with the Wanaque WQP ranges.
- Based on the water quality data collected at the tap, this location does not appear to have been influenced by the Pequannock Gradient water at the time of the sampling event.
- The total copper results ranged from 3.85 to the maximum value of 54.8 mg/L (7th sample, located within the first liter).
- The pH measurements were an average of 7.86, which coincides with the Wanaque WQPs measured in the distribution system.
